Manhole Inspection Summary

Manhole # S19II2008MH

Location Address: **1313 APPLEBY AVE**

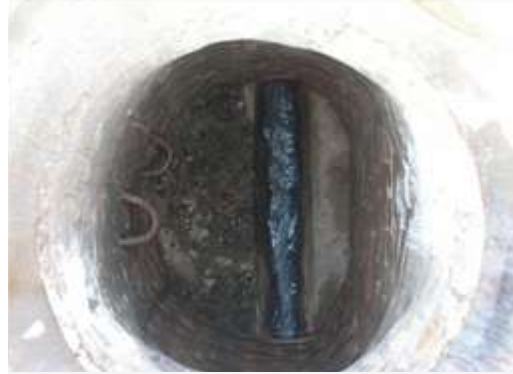
Top View

Corroded and missing steps. Evidence of surcharge - Bench debris.

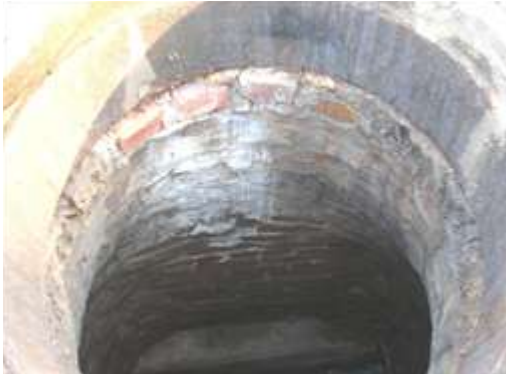
Defect

Frame leaks. Adjustment deterioration. Adjustment, Corbel, and Barrel infiltration - other side.

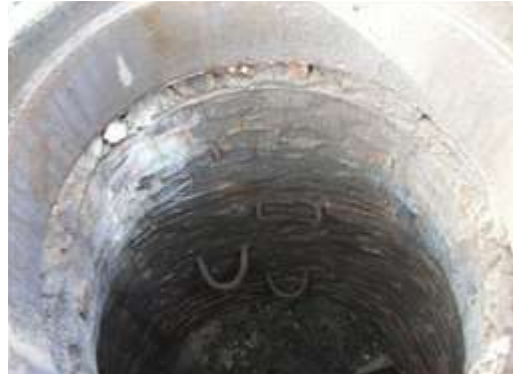
Defect

Frame leaks. Adjustment deterioration. Adjustment, Corbel, and Barrel infiltration.

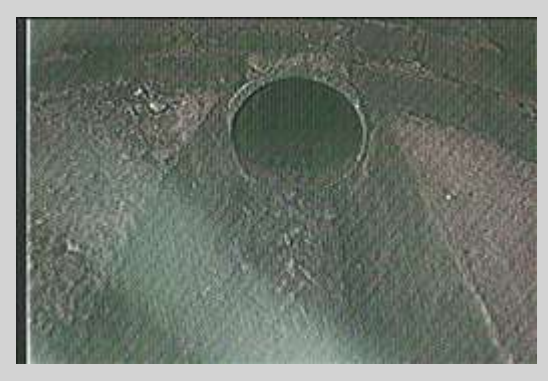
8 in. Circular Gravity Sewer Pipe Out @ 12 O'Clock

Comments **The O12 pipe picture shows Barrel deterioration and infiltration.**

Infiltration: **Evidence** Pipe Seal Cond: **Cracked**

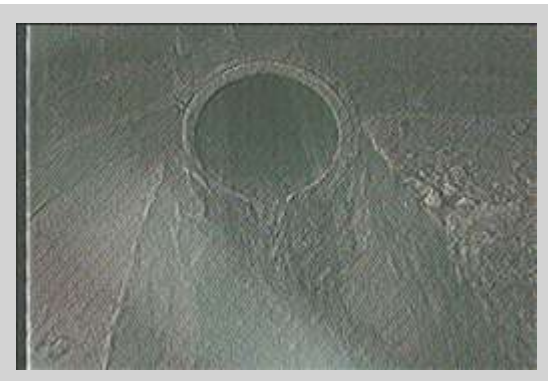
8 in. Circular Gravity Sewer Pipe In @ 6 O'Clock

Deposits: ☐ None ☐ Mud ☐ Sludge ☐ Debris ☒ Grease

Silt Depth: **0** (in.) Deposits Extent: **Light**

Infiltration: **Evidence** Pipe Seal Cond: **Cracked**
